# IST Operations weekly report

Xiaozhi

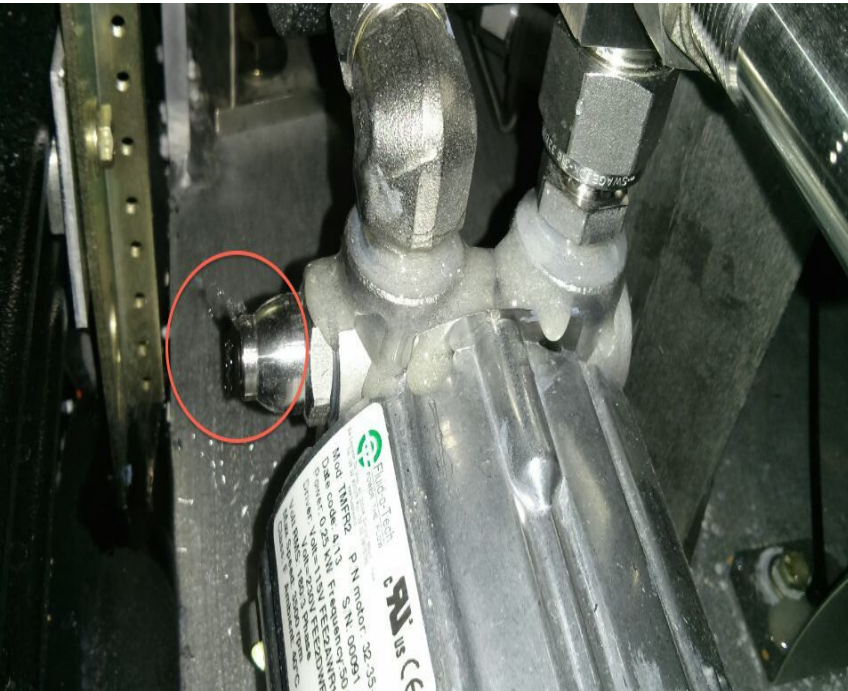
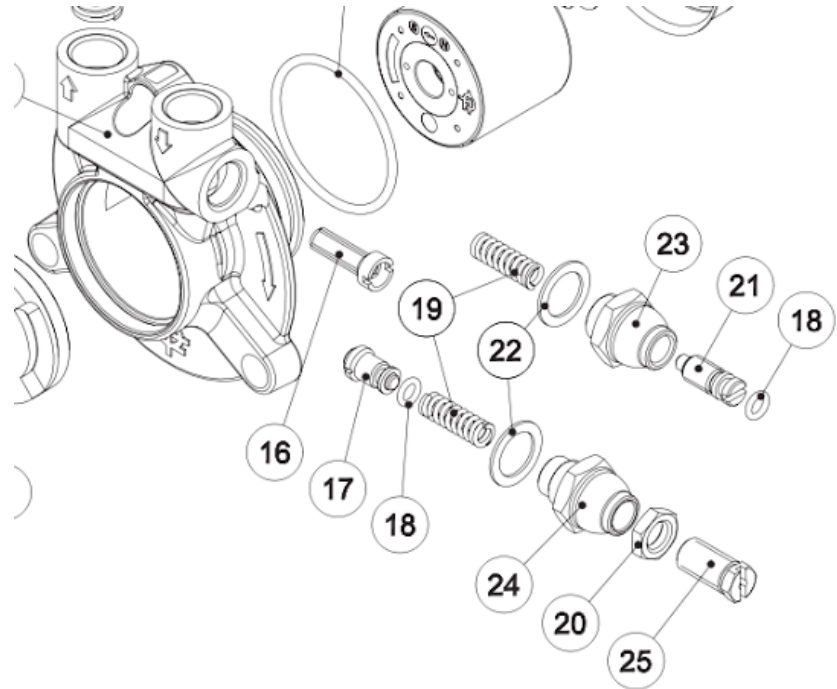
The IST Cooling neck fluid leaking point(left plot), the problem the The O-ring( #18 on the right plot) broken. Gerrit asked the company who send the pump will send us 8 new O-ring for free.
